# Manhole Inspection Summary

Manhole # S25II1004MH

Insp Date: **12/12/06 11:15 AM**

**Location** Address: **1130 43RD ST**

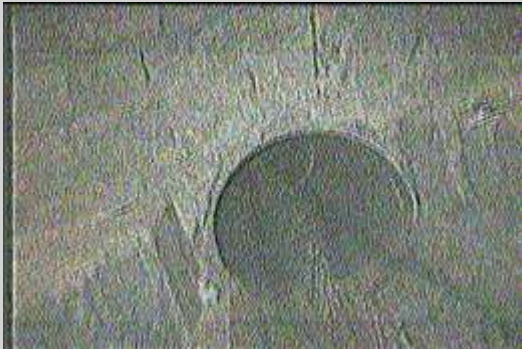
### 8 in. Circular Gravity Sewer Pipe Out @ 12 O'Clock

Rod and Bar (Angled)

Infiltration: **None** Pipe Seal Cond: **Unknown**
